Thermal Images: reveal draughts (when air flows in)

# What is a reasonable surface temperature?

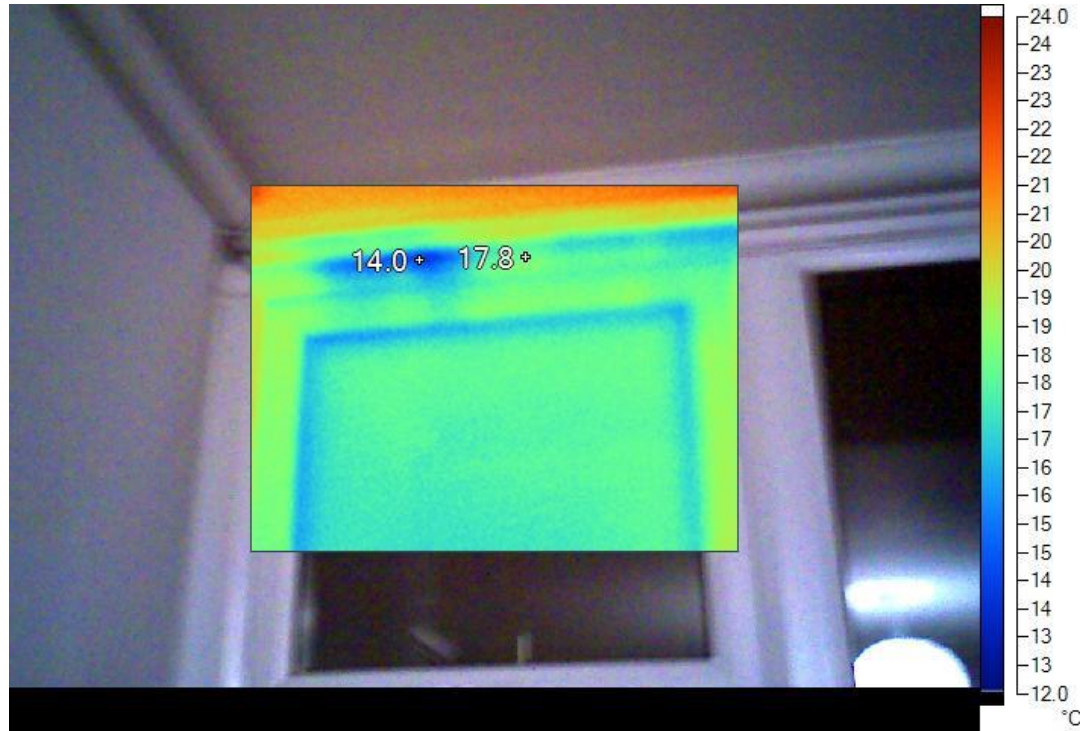
### **Infiltration at the top of the window frame**

This is a badly fitted window. The feathery edge to the cold patch is a key feature of draughts.

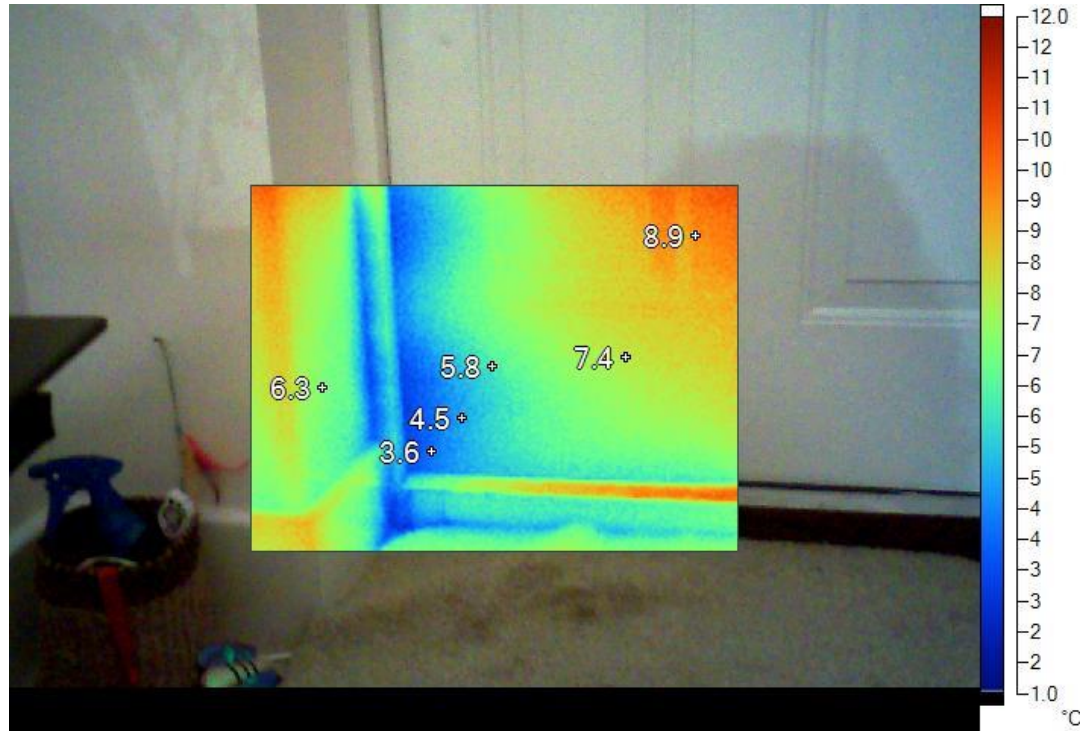
## Infiltration around an external door

Some draught stripping would help here.

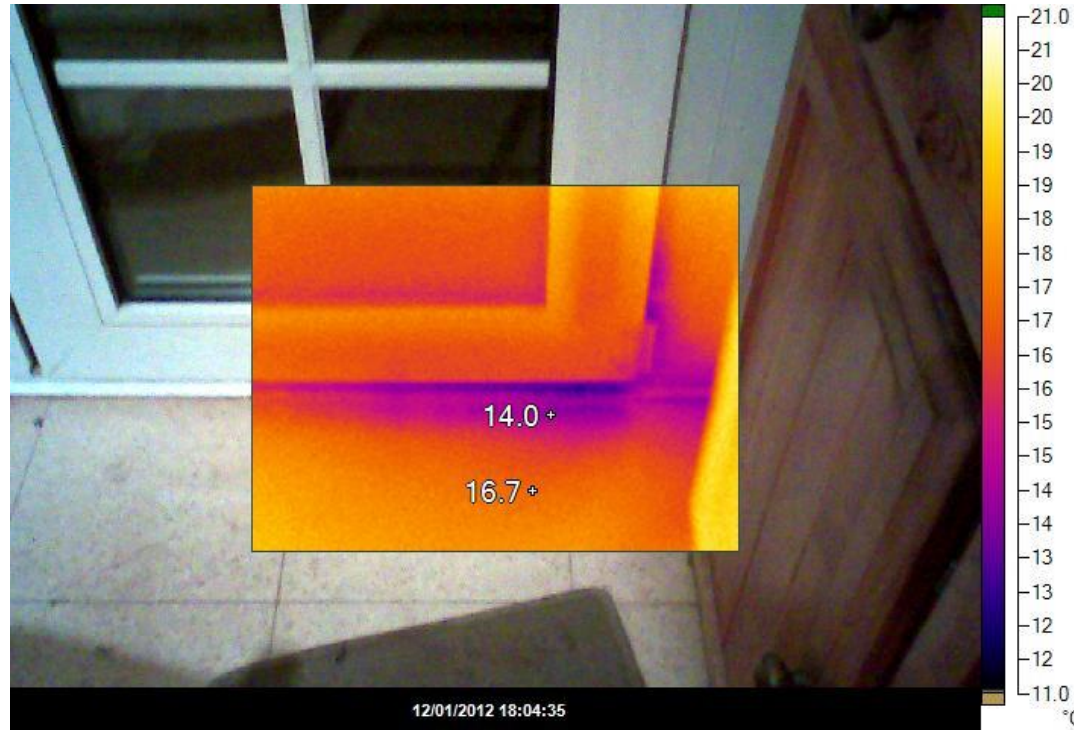
### **Draught at the bottom of the door**

This door is not closing properly against the step. Draught stripping would help but actually this is not too bad.

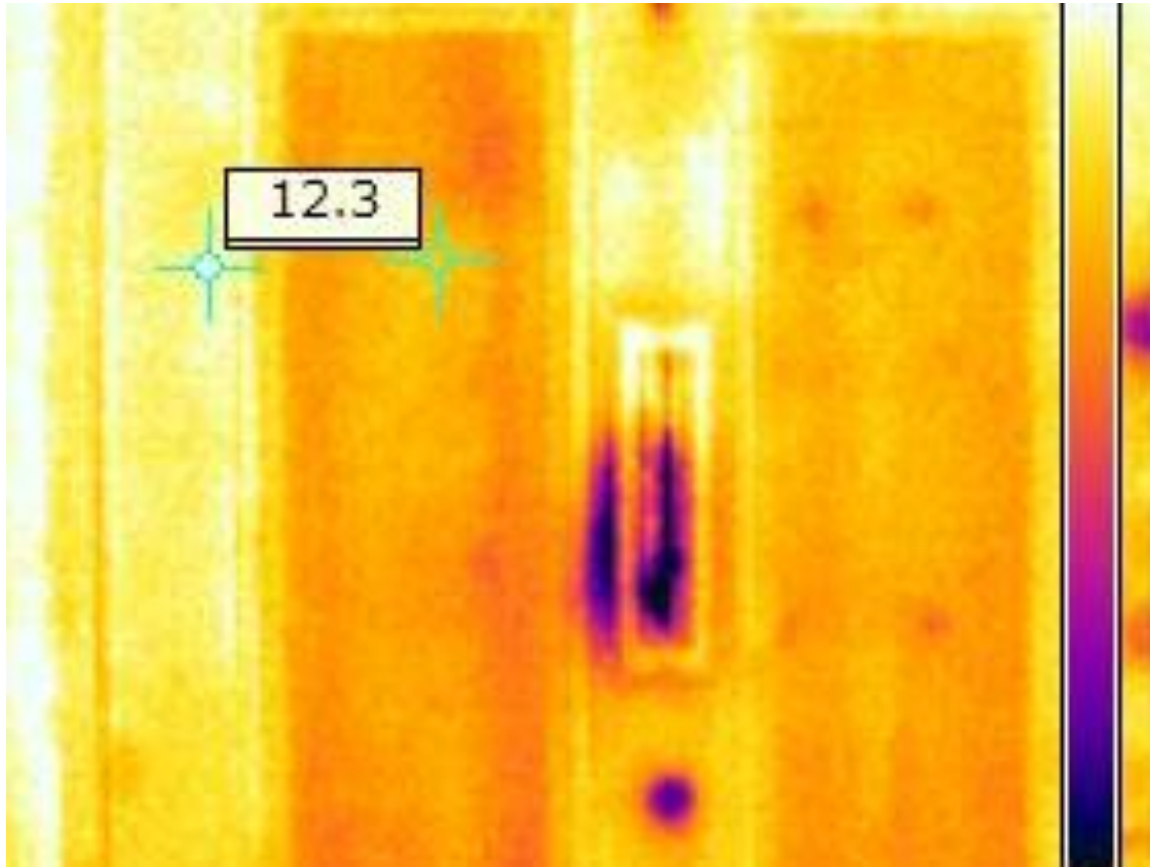
### **Draught through a letter box**

This letterbox is not closing properly and air is leaking through and around the frame.

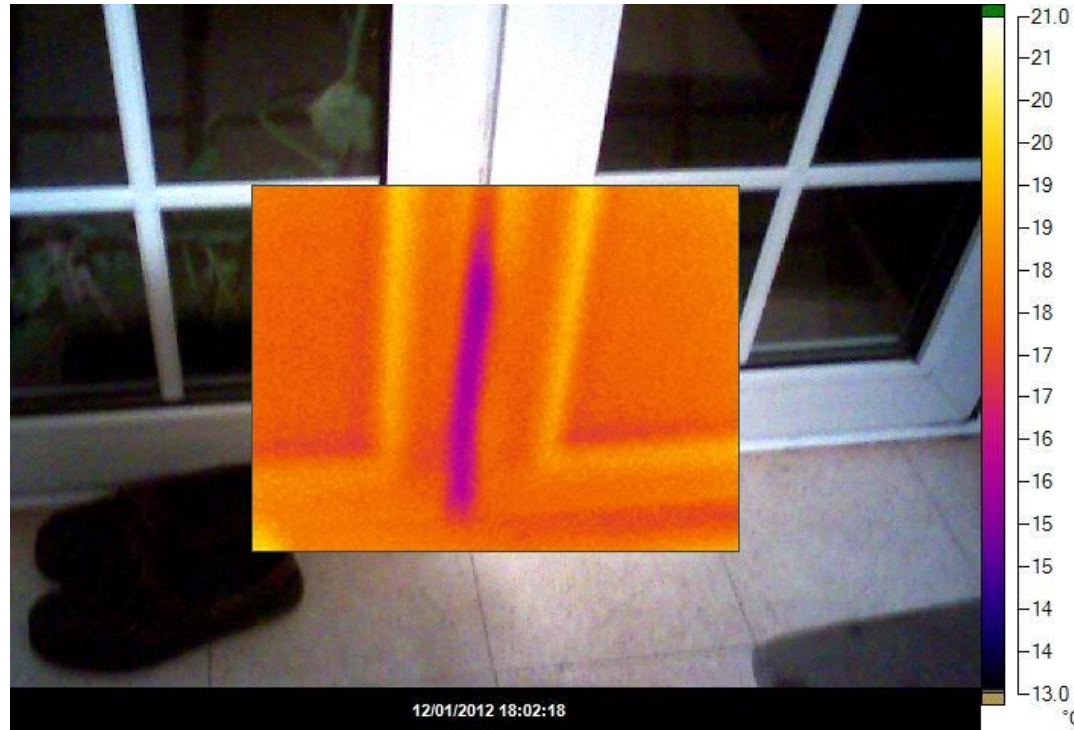
### **Infiltration through french windows**

It is tricky to fix draughts in french windows - in this case there is a problem just in the lower part of the door.

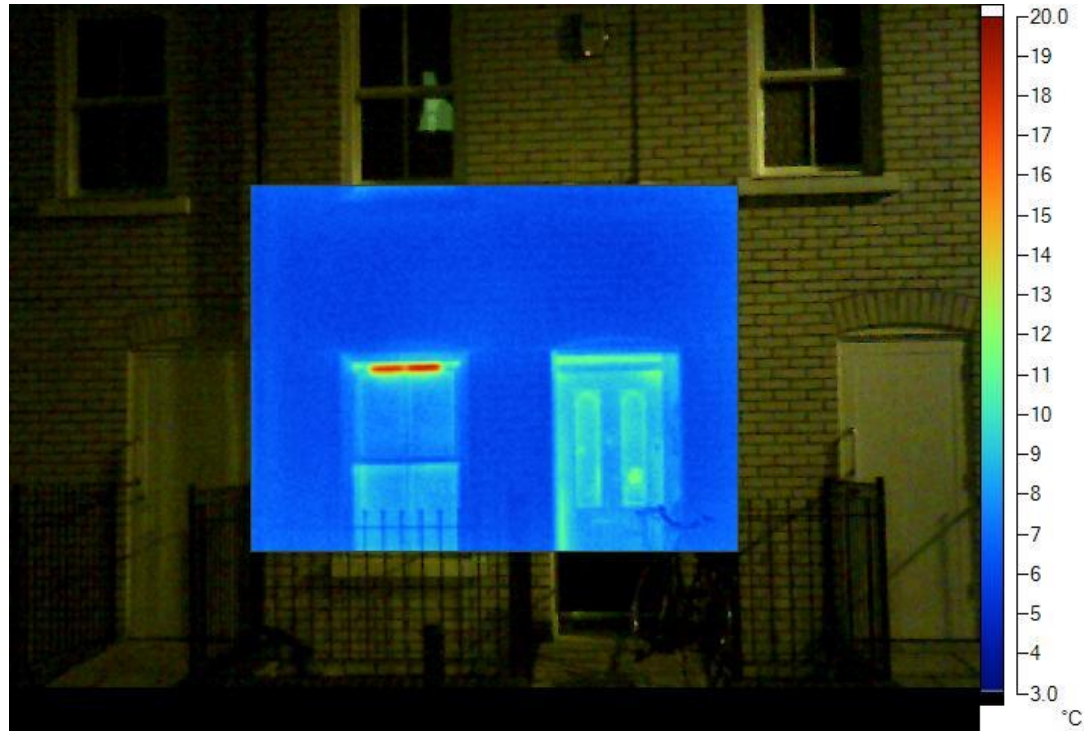
### **The vent above the window is open**

Heat is streaming out through the vent above this window. Some windows have fixed vents, in other cases you can close the vent. But you do need some ventilation in each room so you may want to leave it open.

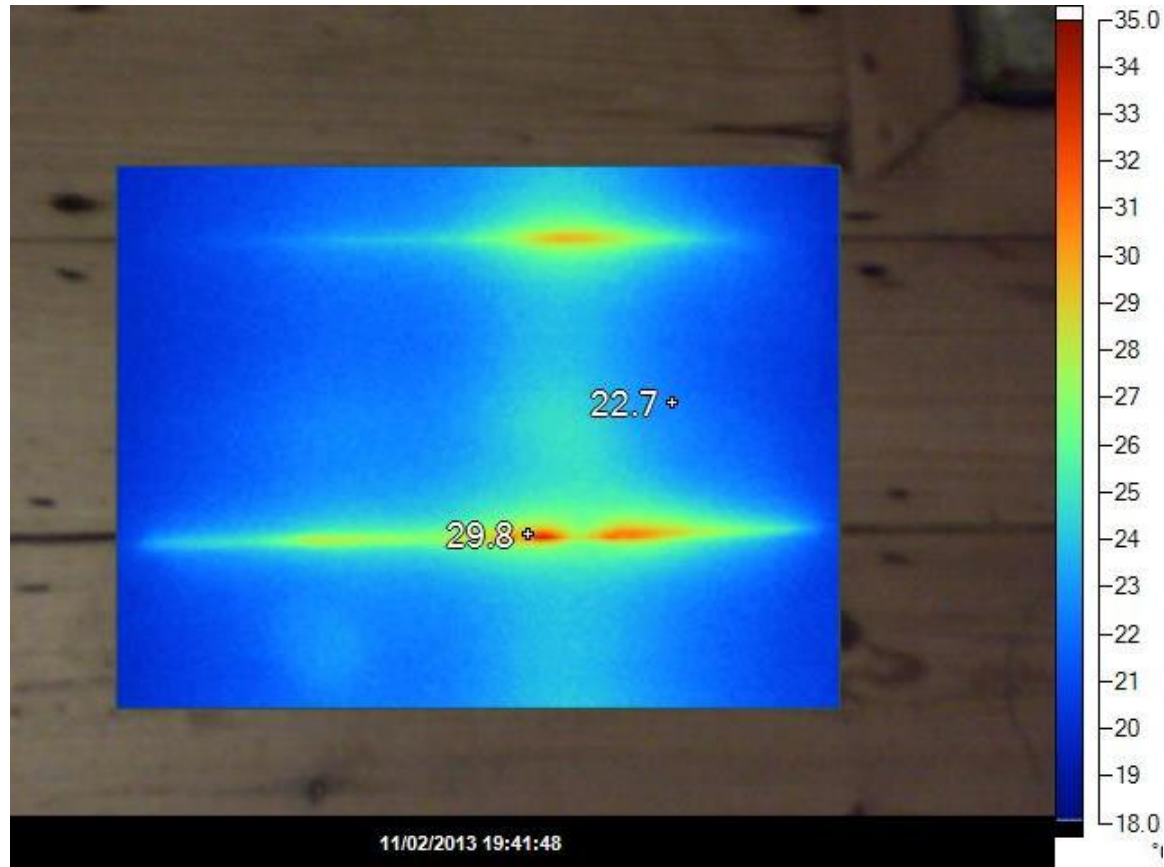
### Unlagged heating pipes

The heat is leaking up from under the floor - pipes under the wooden floor are heating the underfloor void and need to be lagged.

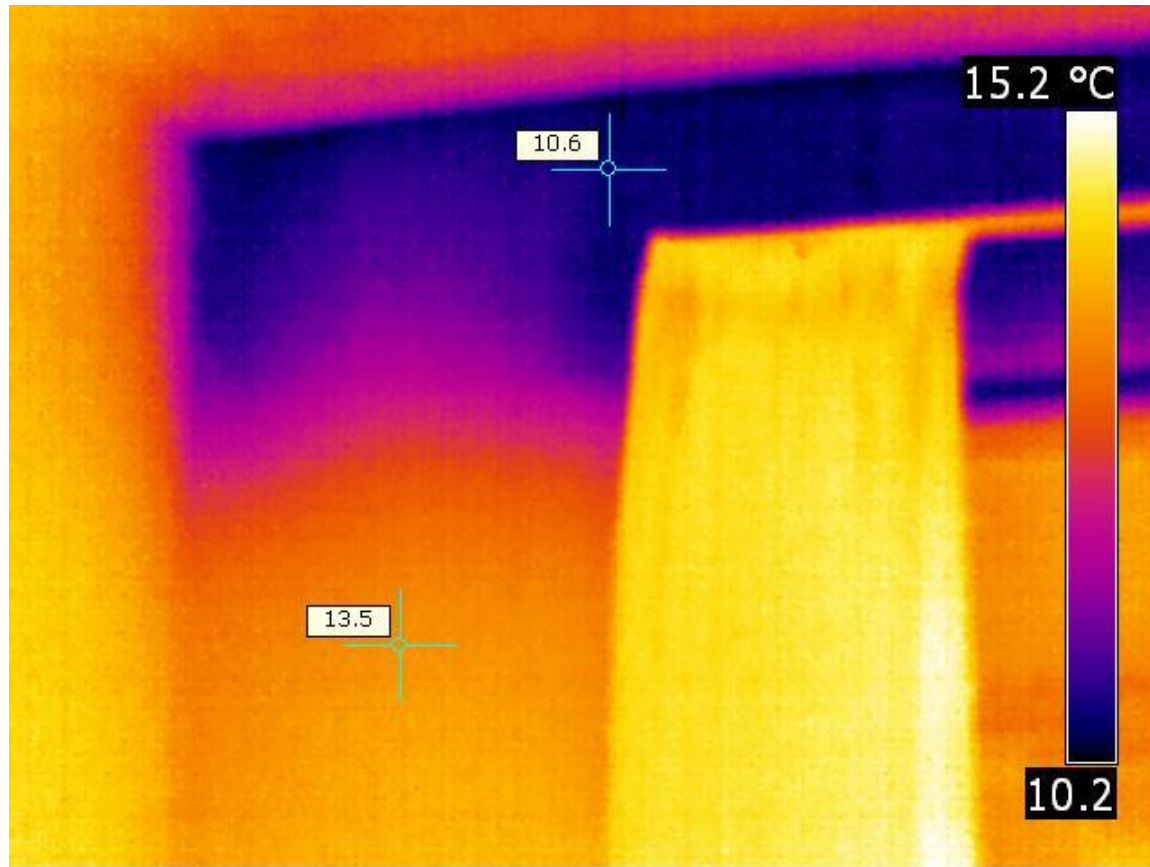
## Slumped cavity wall insulation

The top of this first floor bedroom wall is much colder than the rest. It could be that cavity wall insulation has slumped, or it was never filled properly.

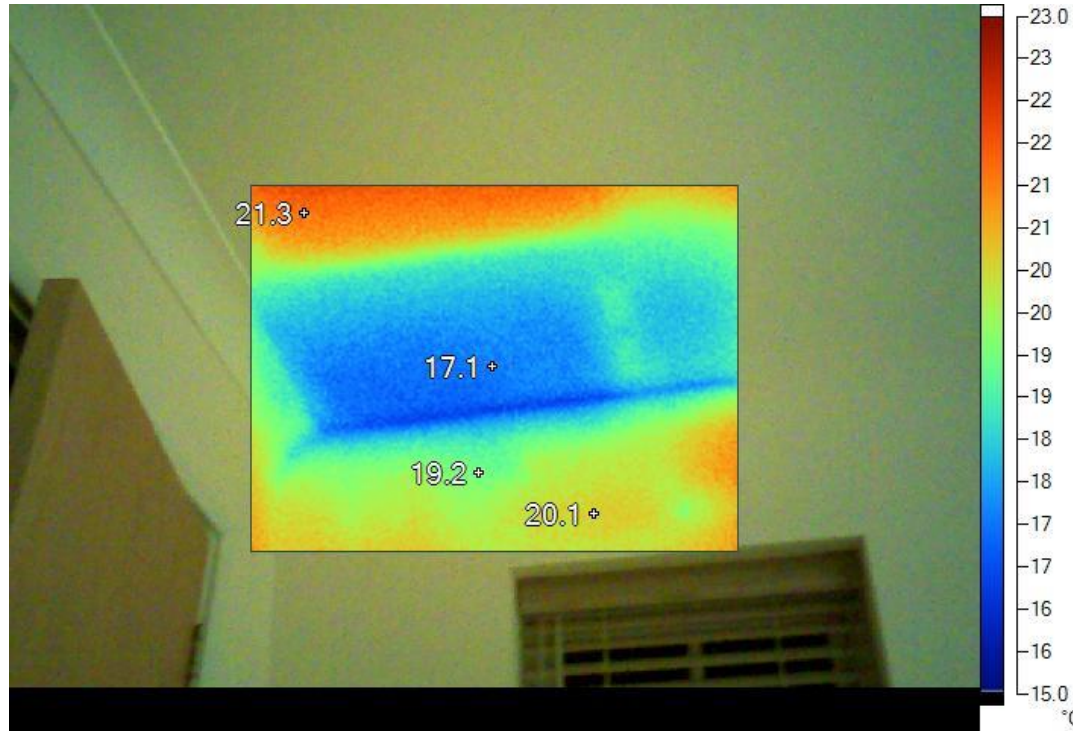
### **Insulation not taken to the edge of the roof**

This is a first floor room below the loft above which is insulated – but not to the edge. Sometimes this is necessary to make sure there is enough ventilation around the wooden roof beams but this gap is larger than usual.

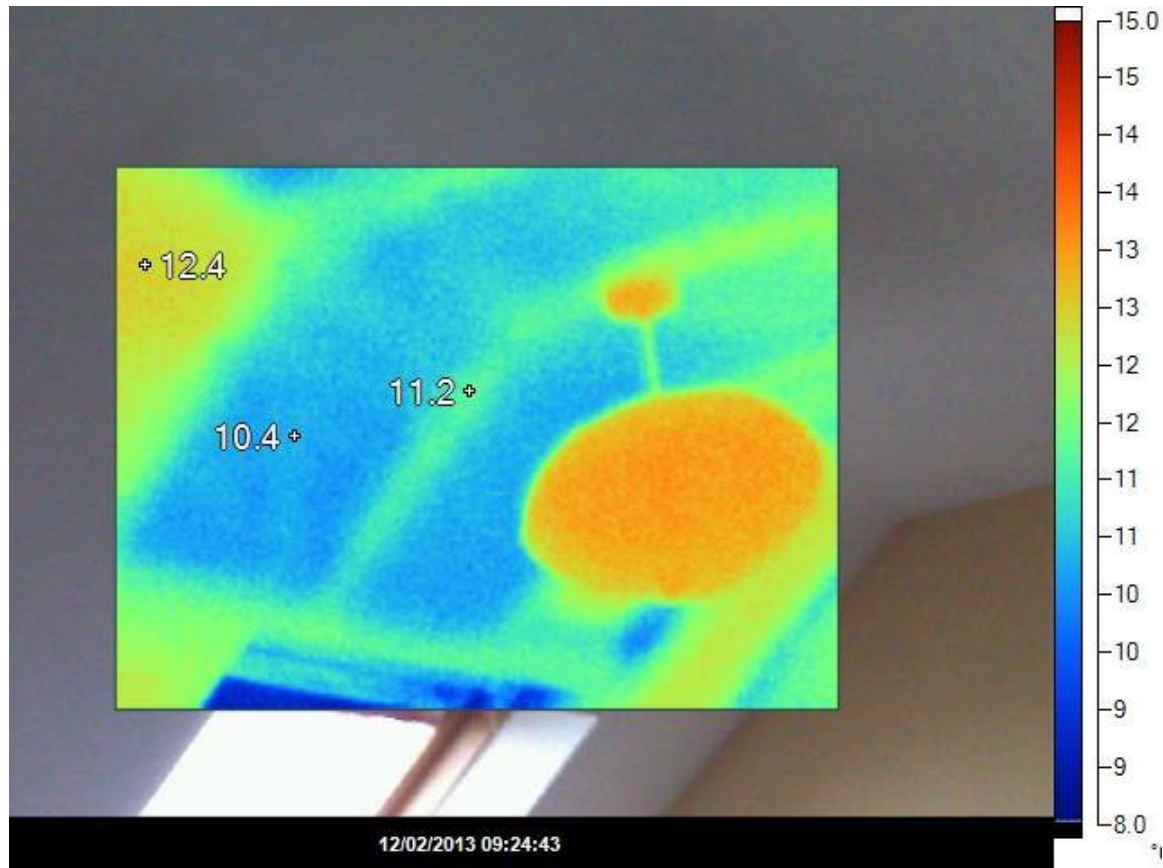
## Missing insulation panels

This is in the sloping ceiling of an attic room. There is insulation on the left but two large cold sections are missing to the right of it. That is a large area with 2C difference in temperature which is a significant heat loss.

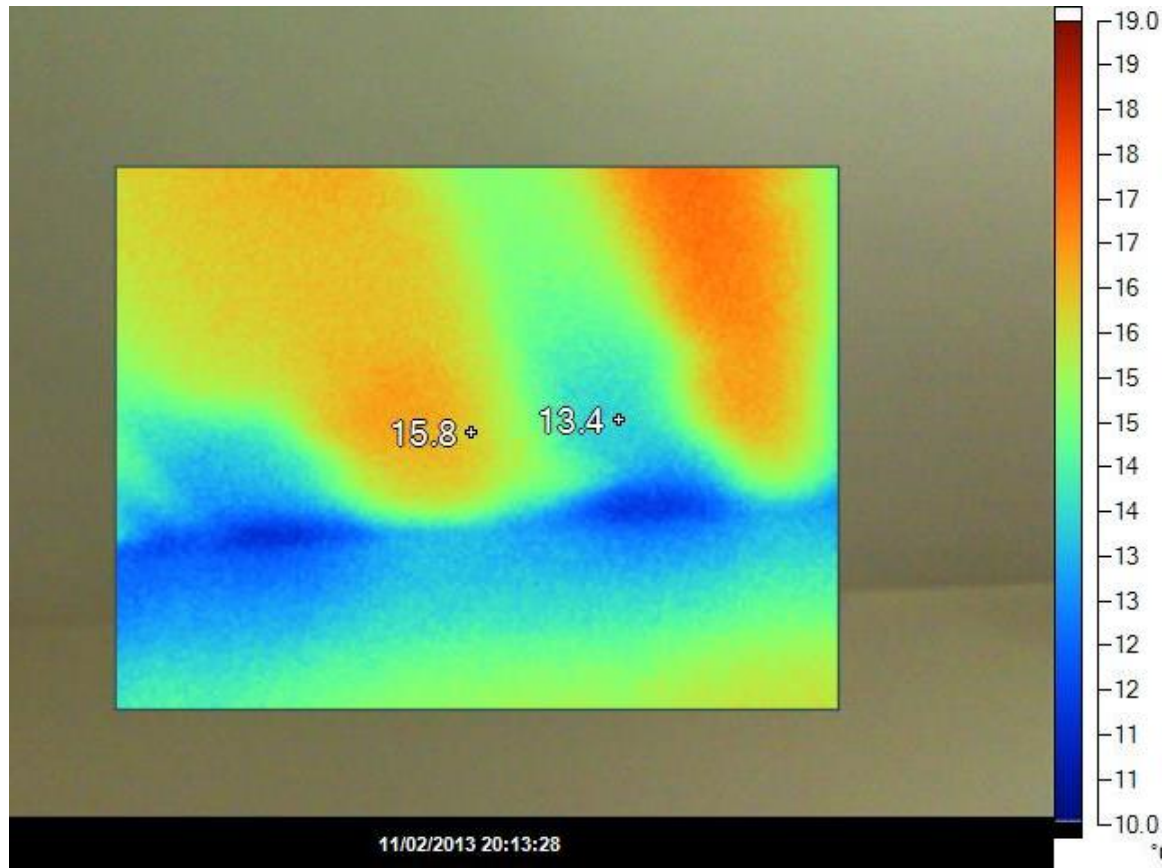
## Insulation not to the edge of the roof

This is not so clear but it looks like missing insulation at the edge of the roof, It may or may not be possible to fix it while retaining ventilation around the rafters.

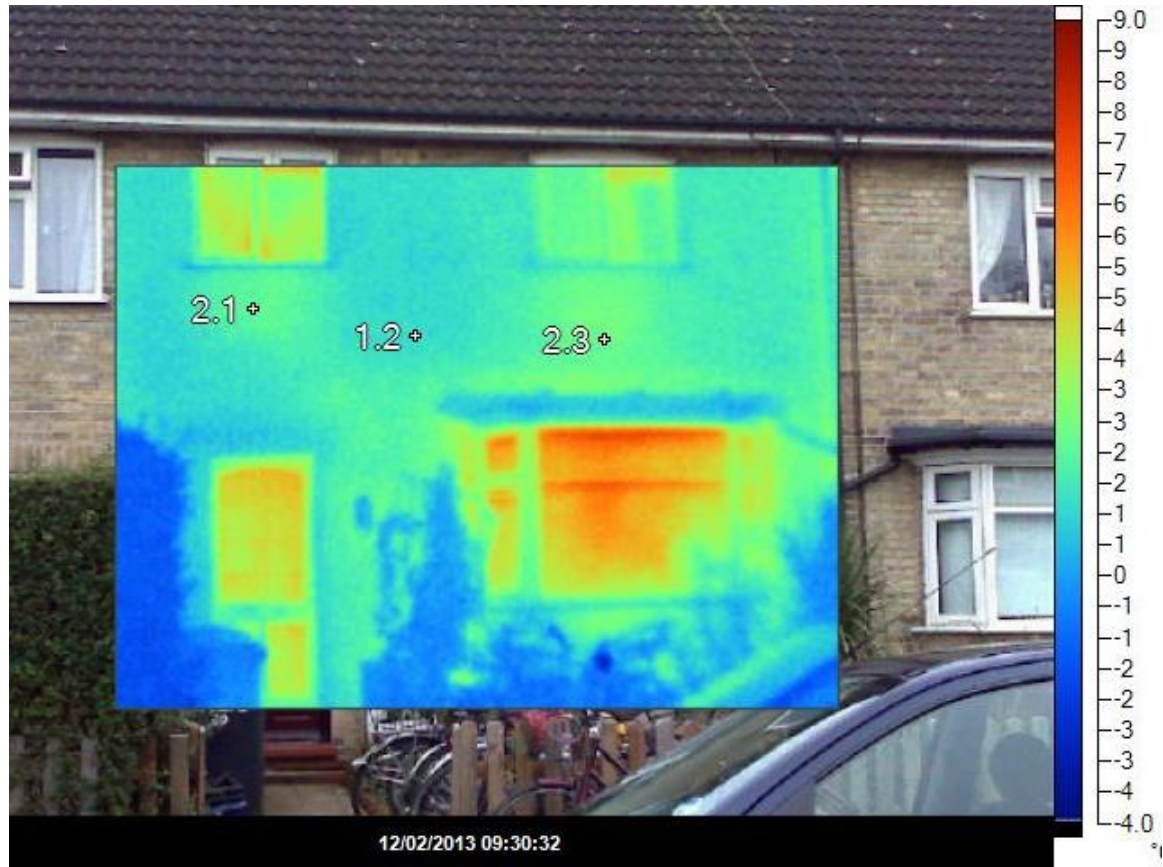
## Missing radiator panels,

There is heat loss from under the windows, where radiators are warming the walls. Radiator panels would help. This picture was taken in the morning and curtains were open. You can see the windows are warm, especially the front sitting room.

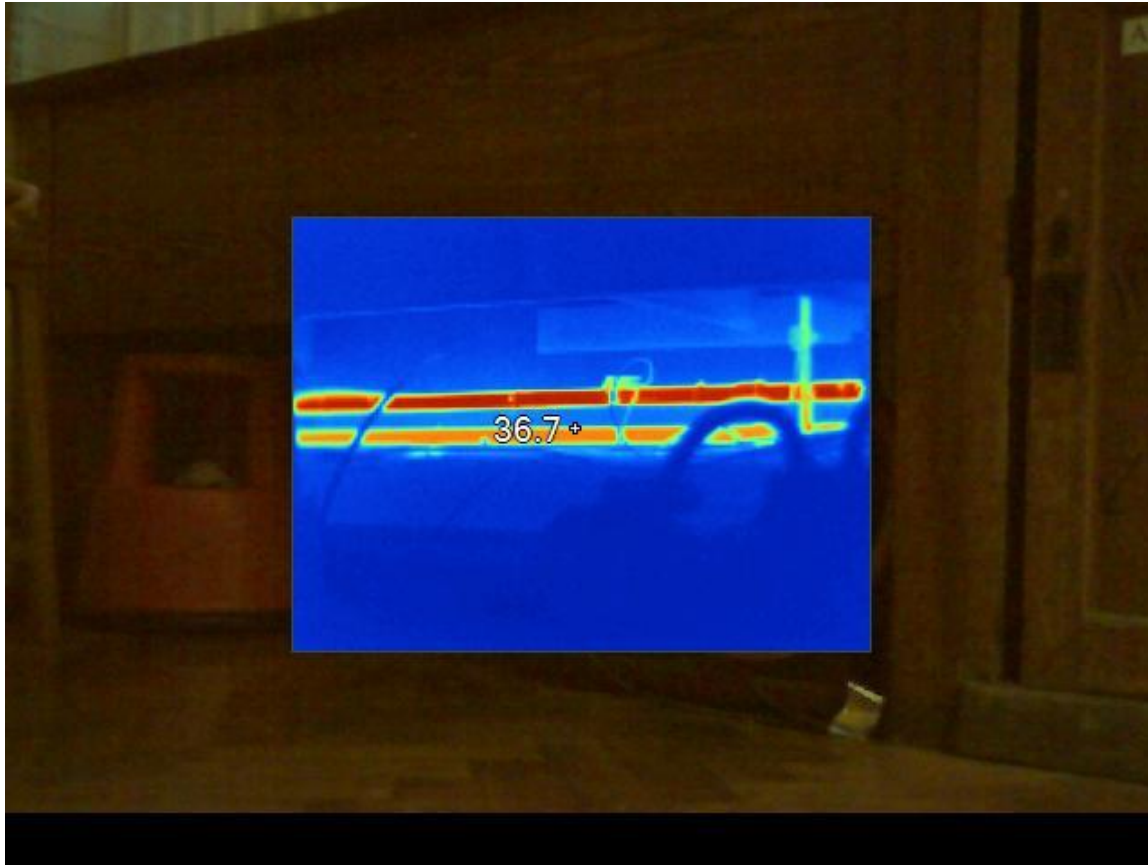
## Unlagged pipes

These pipes (at the back of kitchen cupboards) are not lagged.

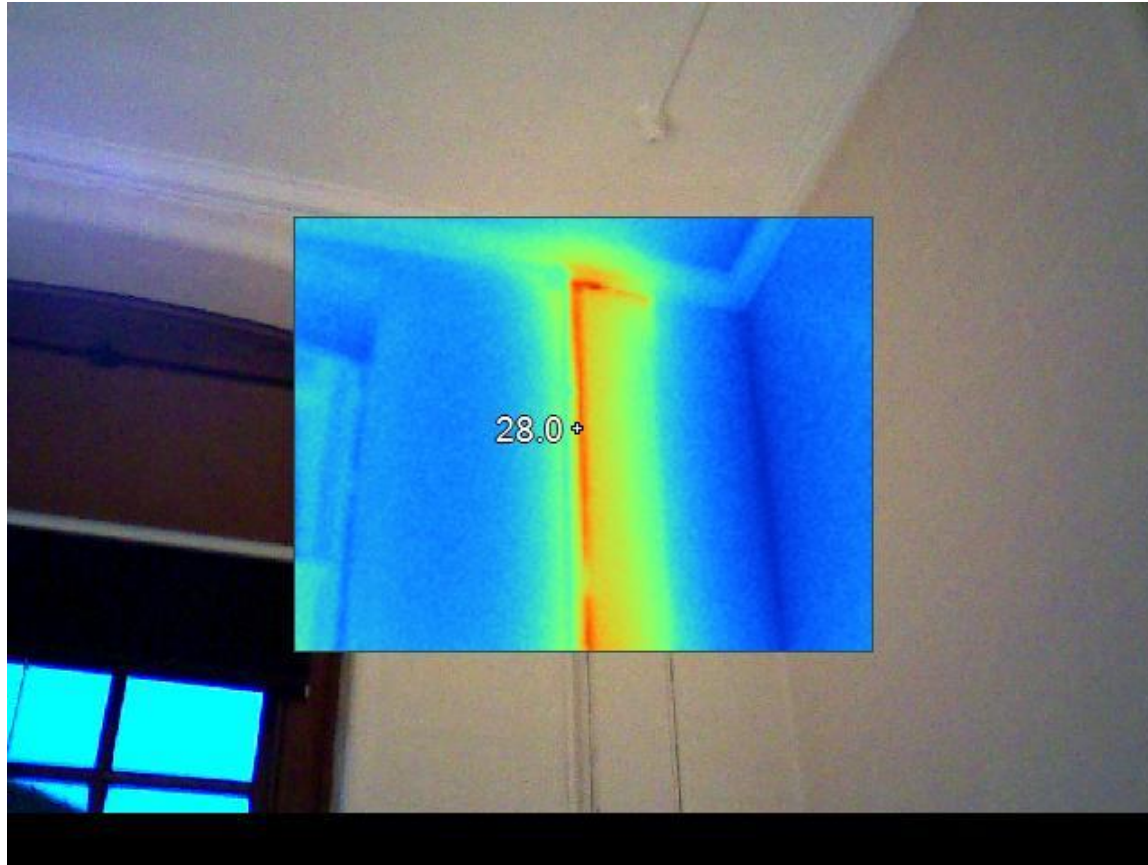
### **Heat leaking from hot water pipes**

The heat loss from the pipes shows they need more insulation to stop the heat leaking out. If these are radiator pipes and the heat loss is useful then there is no problem. If they feed taps then the heat loss is definitely not wanted especially in summer.

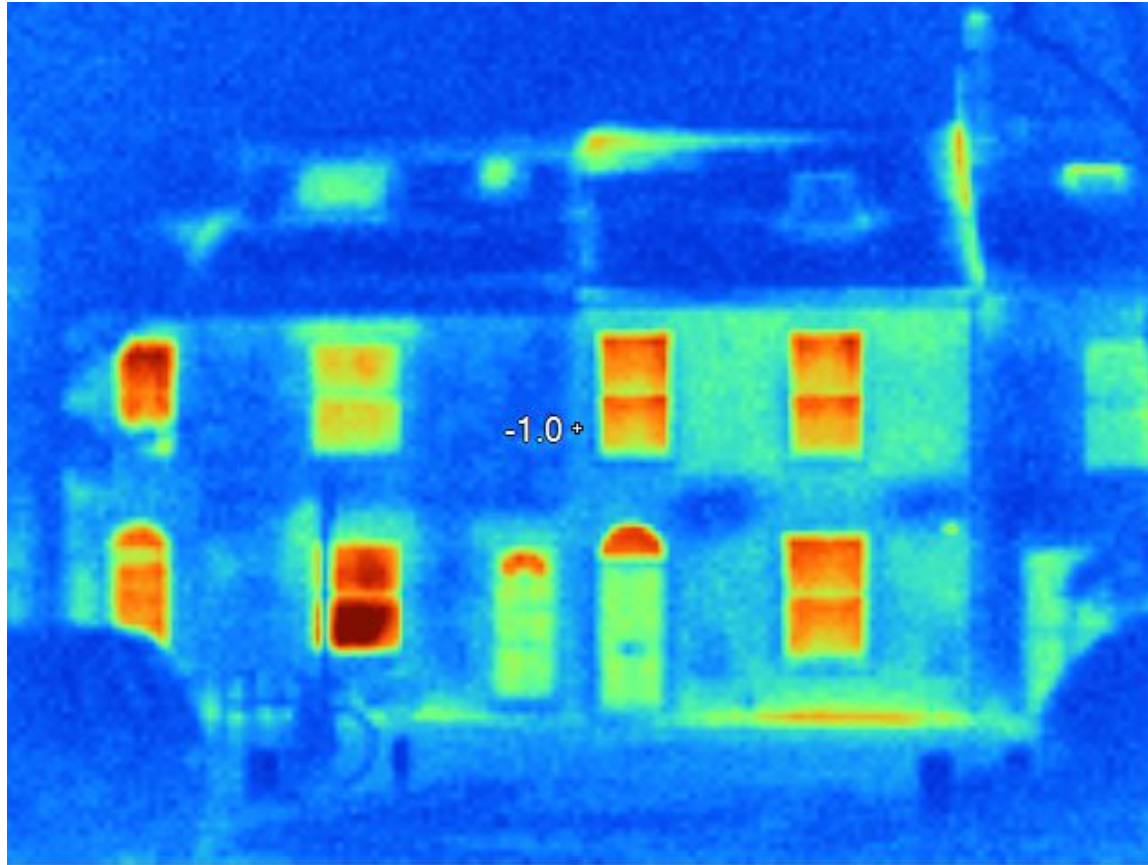
## Several heat leaks from the outside

Note the high heat loss at ground level, especially on the right, probably from the underfloor void. Floor insulation would reduce this. Also heat leaking from the chimney - could be bad pointing. If the hot spot on the ridge is not a vent this needs checking.

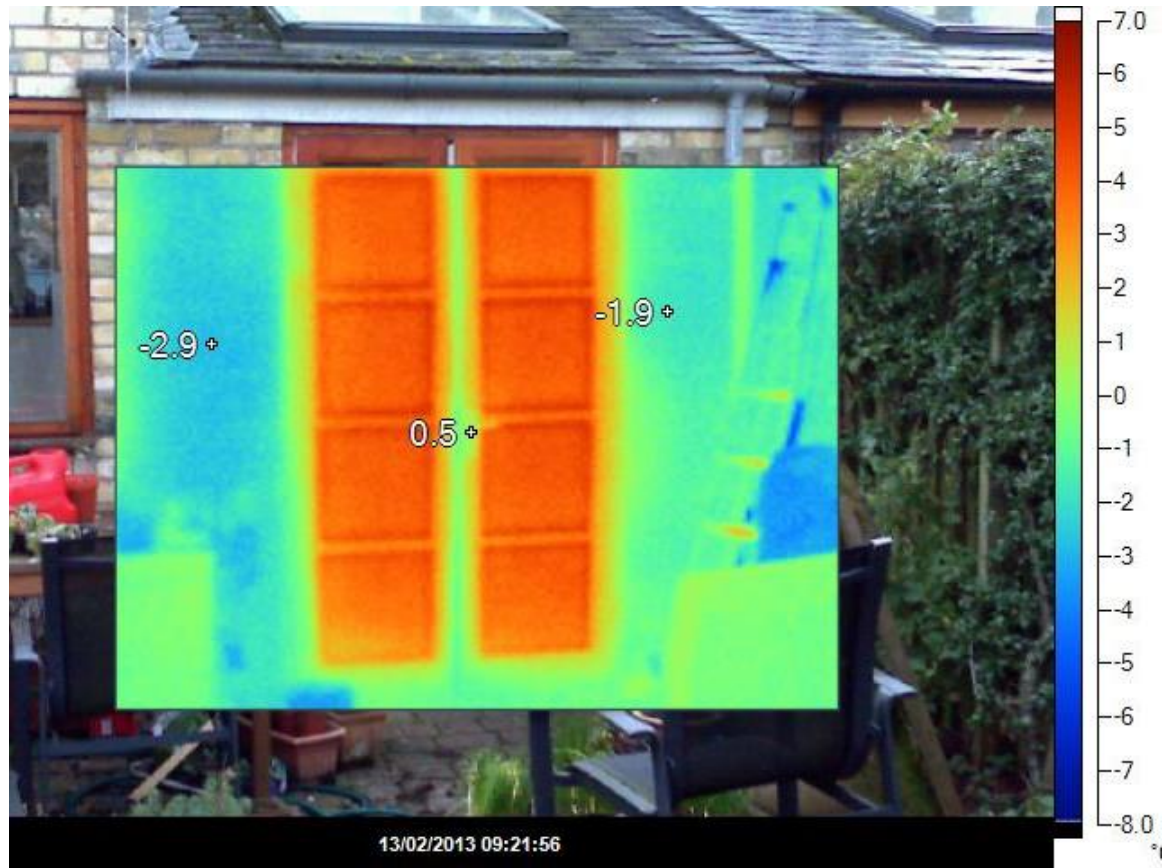
## Windows leaking heat

These French windows are double glazed. The windows are much warmer than the walls, though still much cooler than inside. Maybe they need an upgrade.

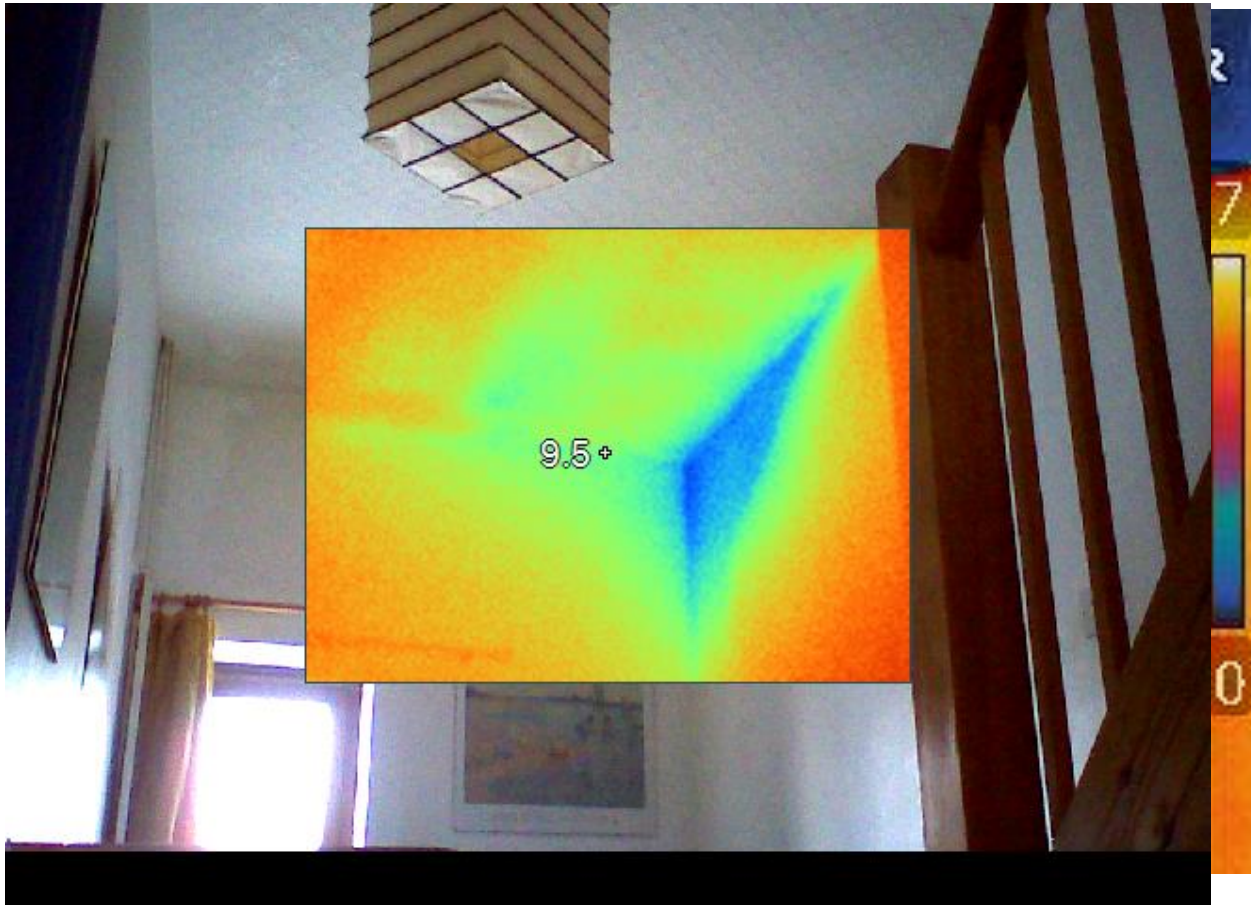
## Heat leakage around insulation

The front wall of this house is insulated externally but the neighbour's house is not. The party wall is cold in the corner because the heat leaks through from the front wall of the next house.

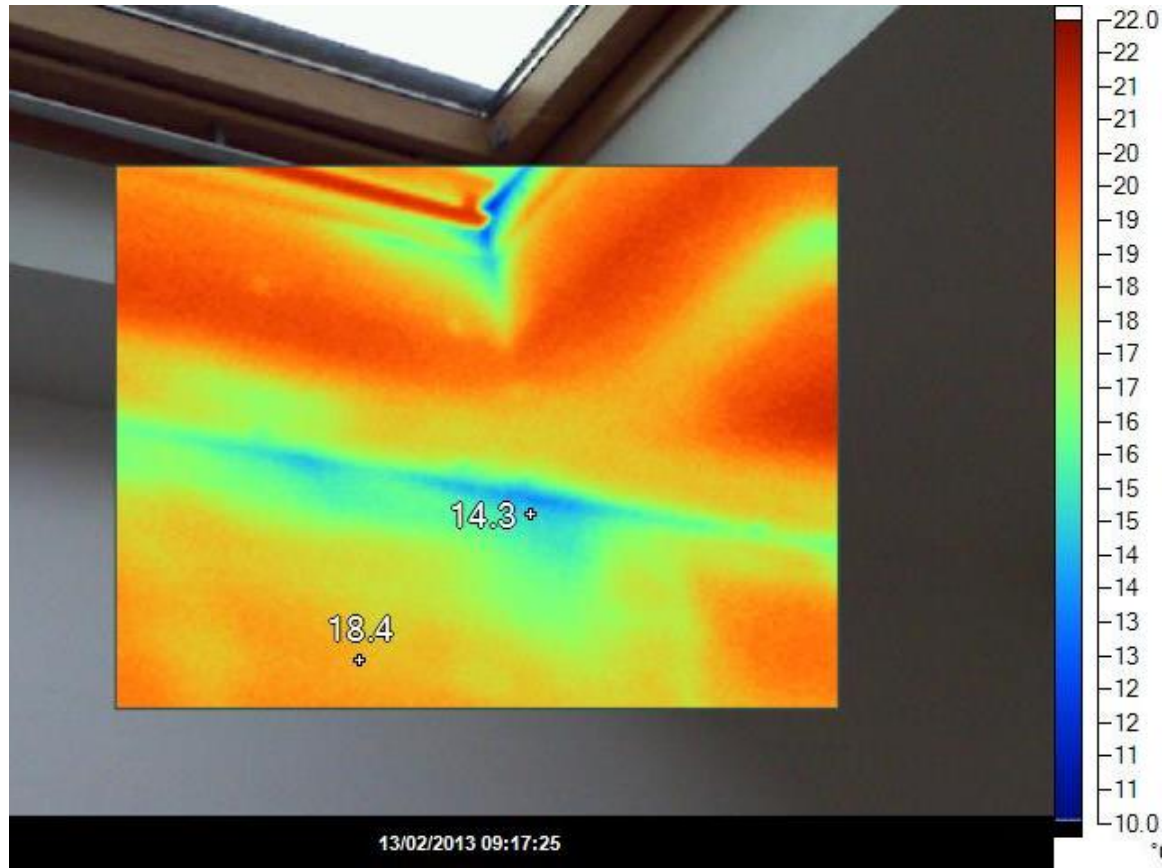
## Thermal bridge at the top of the wall

There seems to be a cold bridge at the junction between the wall and the sloping roof. (The window is fine).

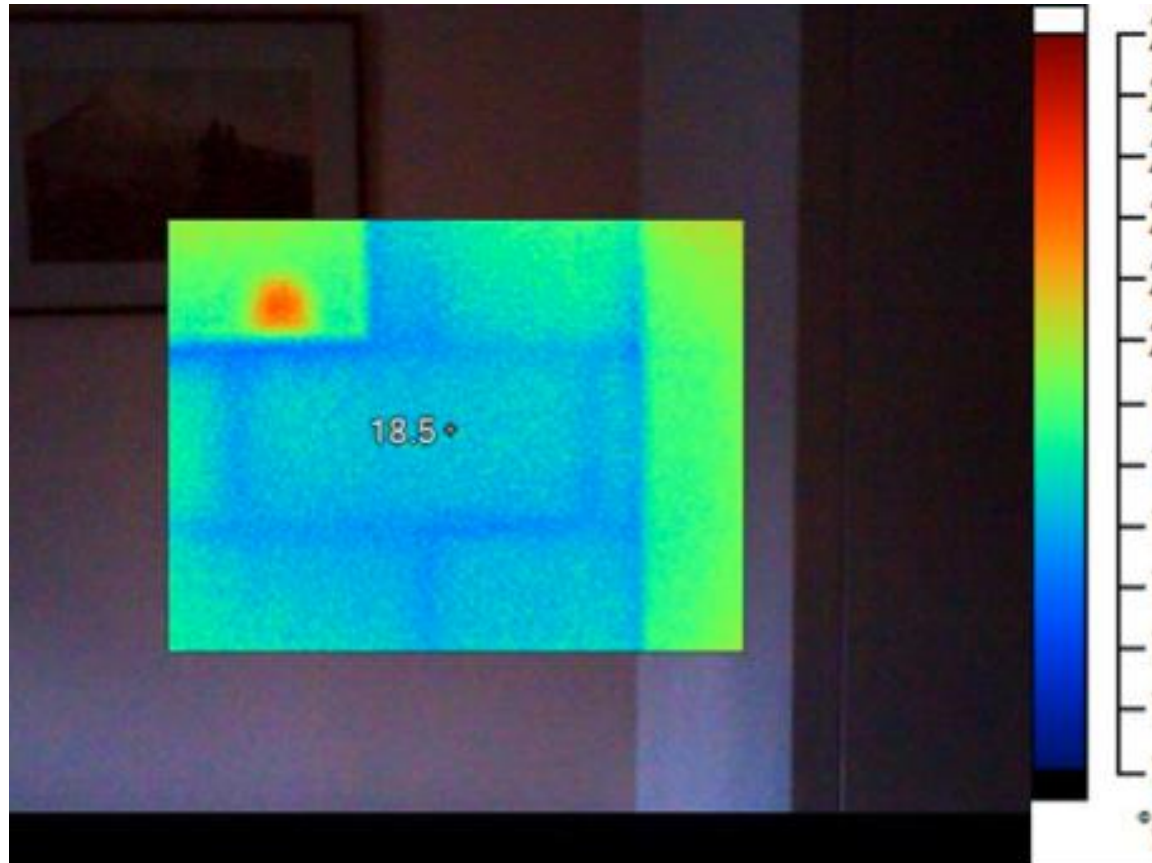
### **Breeze blocks in the wall**

This was a dormer room which has been plastered straight over the masonry: you can see the outline of the breeze blocks under the plaster. This is not a problem that needs fixing but it is interesting to see it.

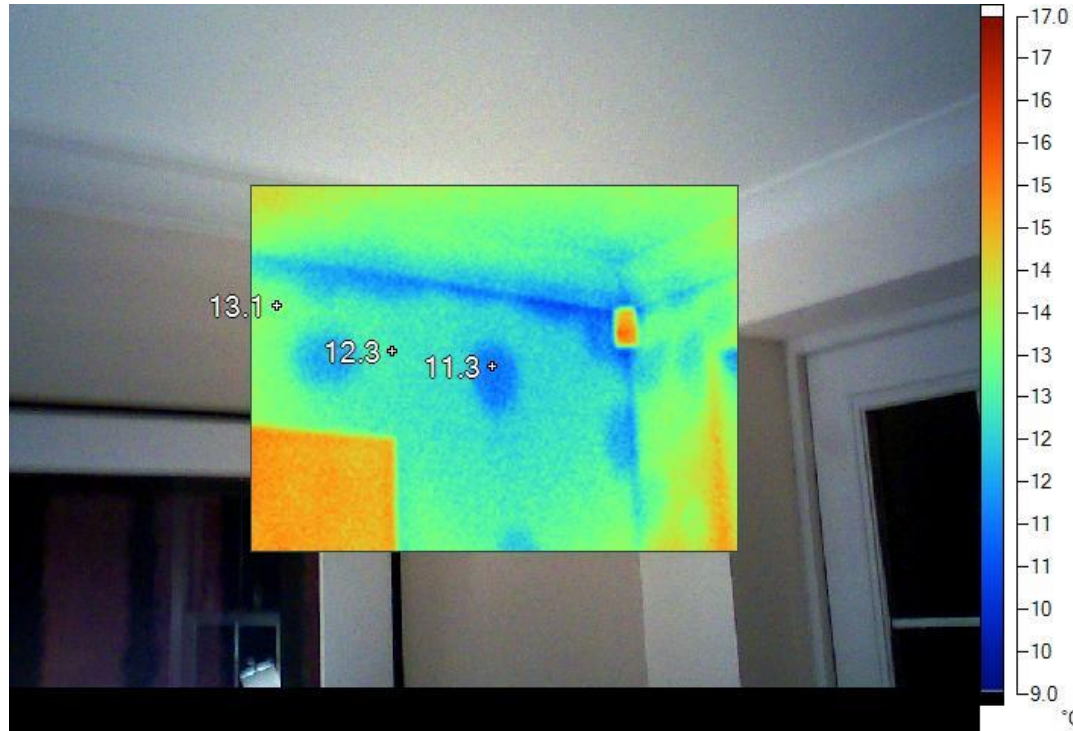
### Plasterboard adhesive

The regular splodges are dabs of glue holding the plasterboard in place. The glue transmits heat effectively to the masonry behind. Between the splodges the plaster doesn't quite touch the solid wall so there is a small air gap. This is not a defect that needs fixing – the areas are small and the temperature difference is only 1C.
